West Sound Watersheds Council 2011 Three-Year Work Plan Update

West Sound Watersheds Water Type Assessment

West Sound Systematic Water Type Assessment

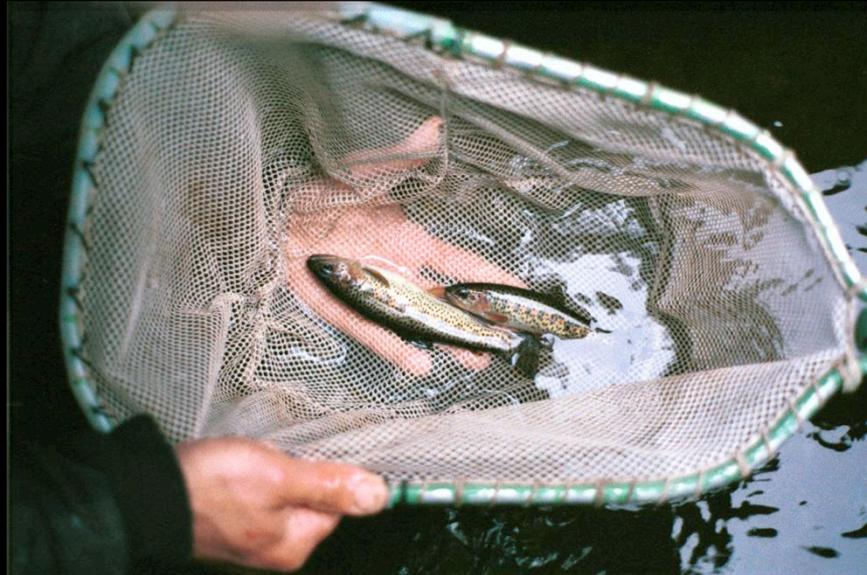
WA Department of Natural Resources Water Types

WAC 222-16-031	Type	Buffer Size
Type S	Shorelines	Large
Type F	Fish Bearing	Medium
Type N (p,s)	Non Fish-Bearing	Small or none
Type U	Unclassified	TBD

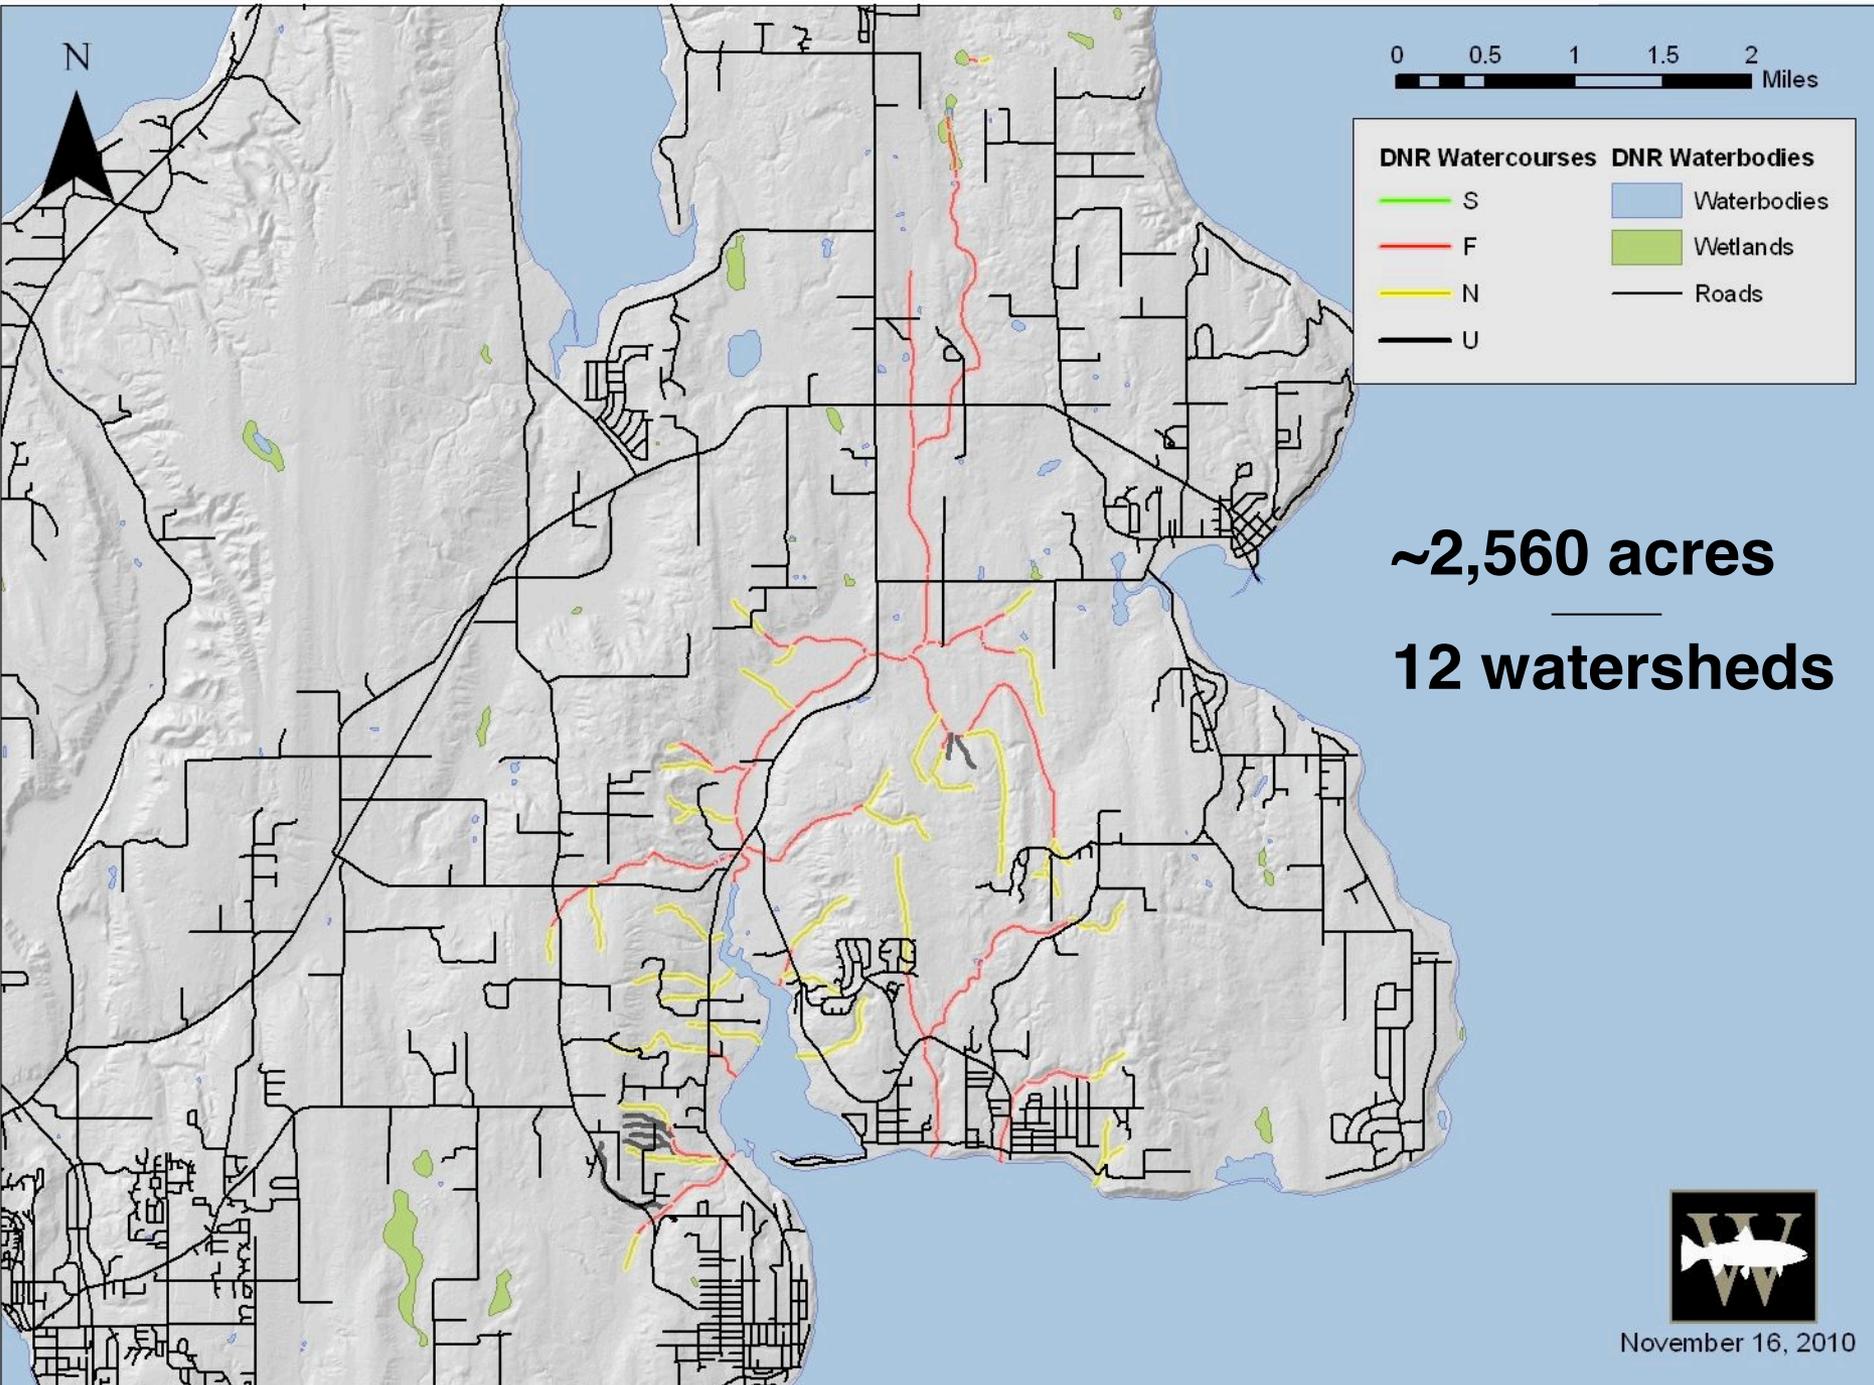
~2,560 acres
12 watersheds

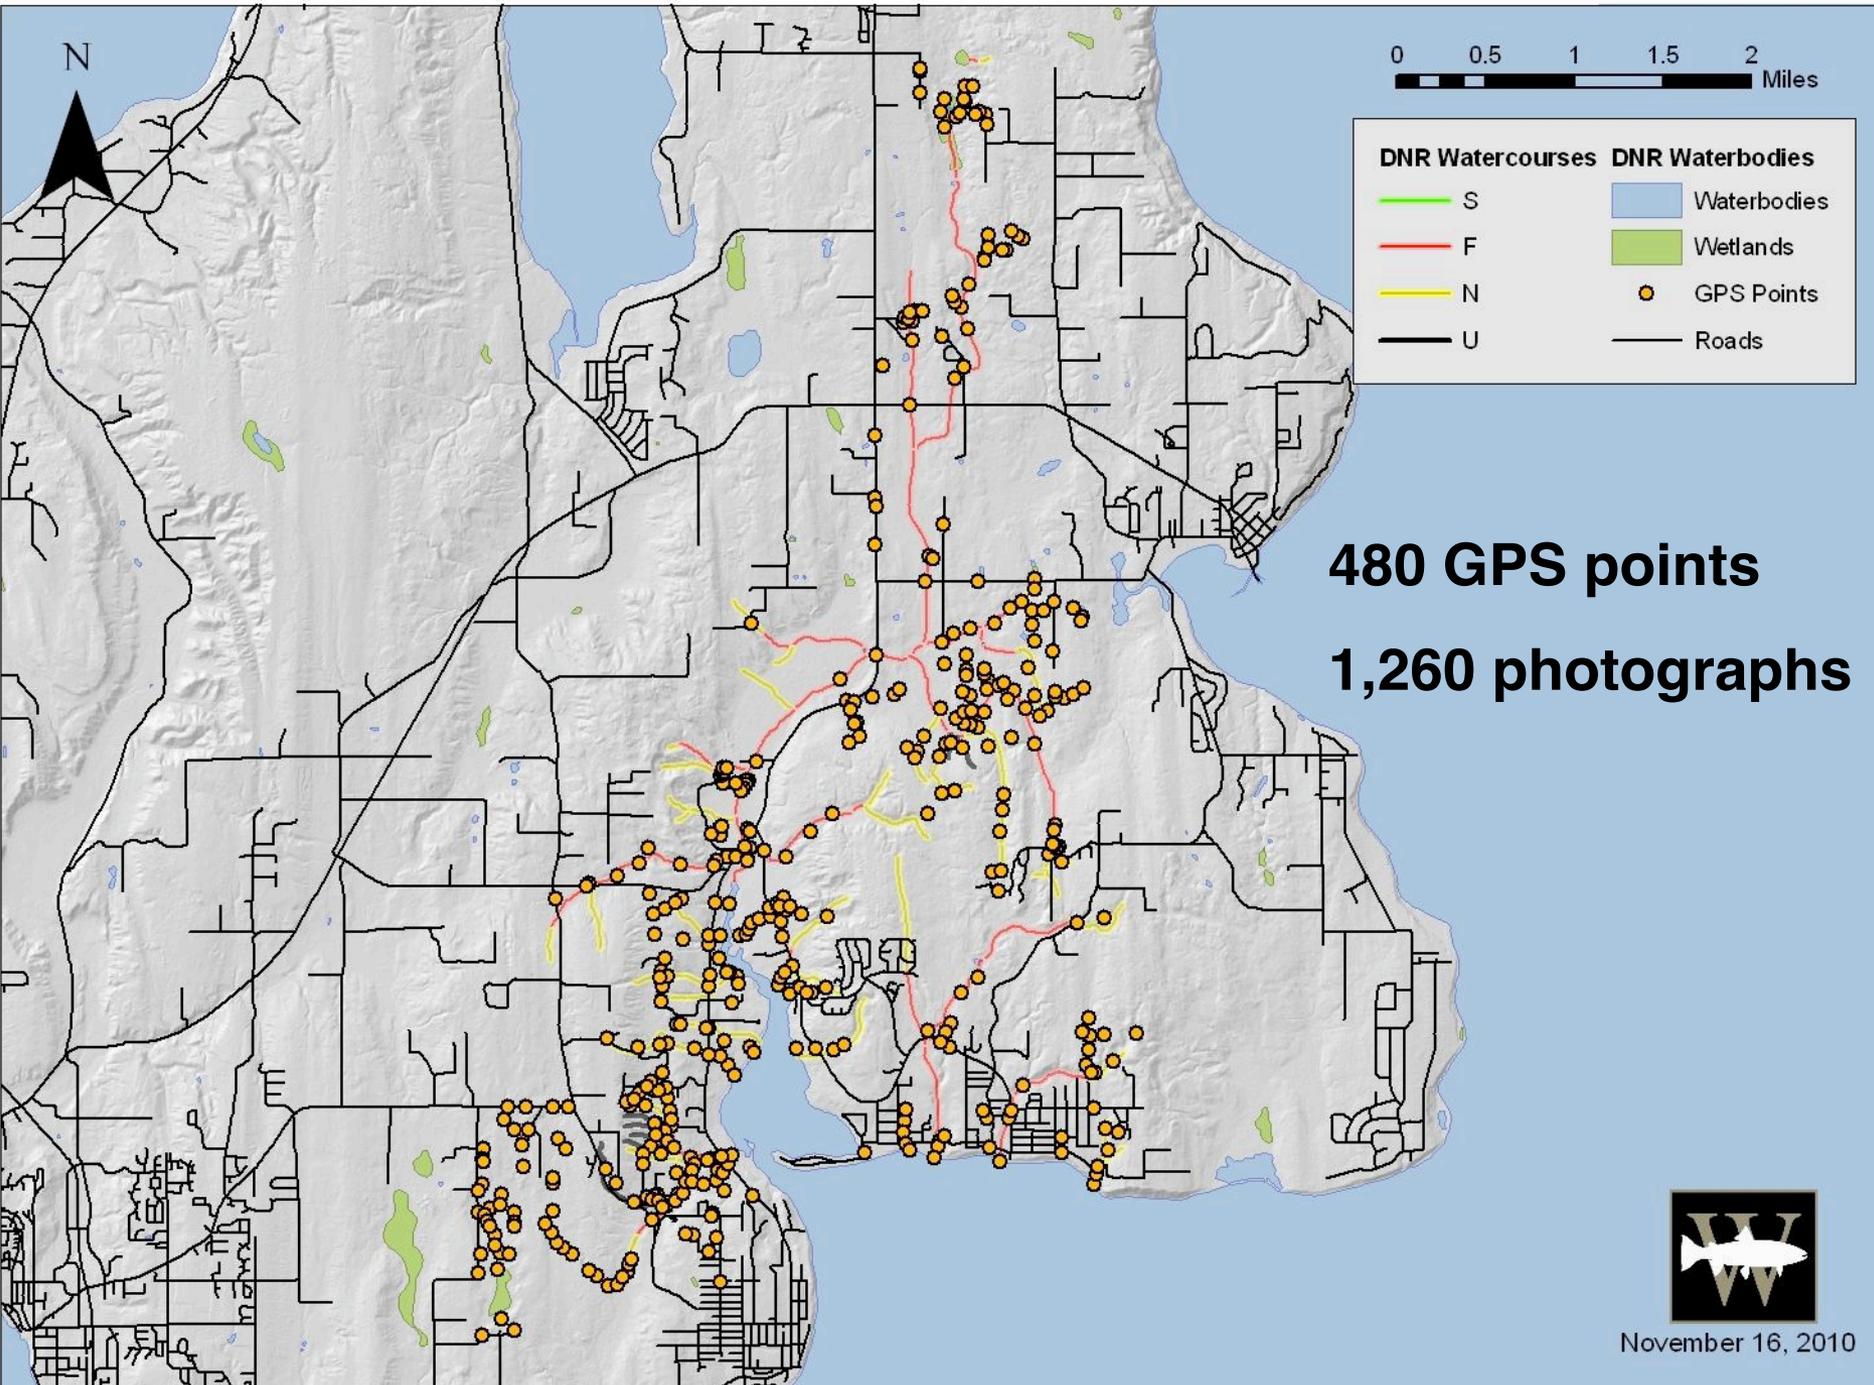
480 GPS points
1,260 photographs

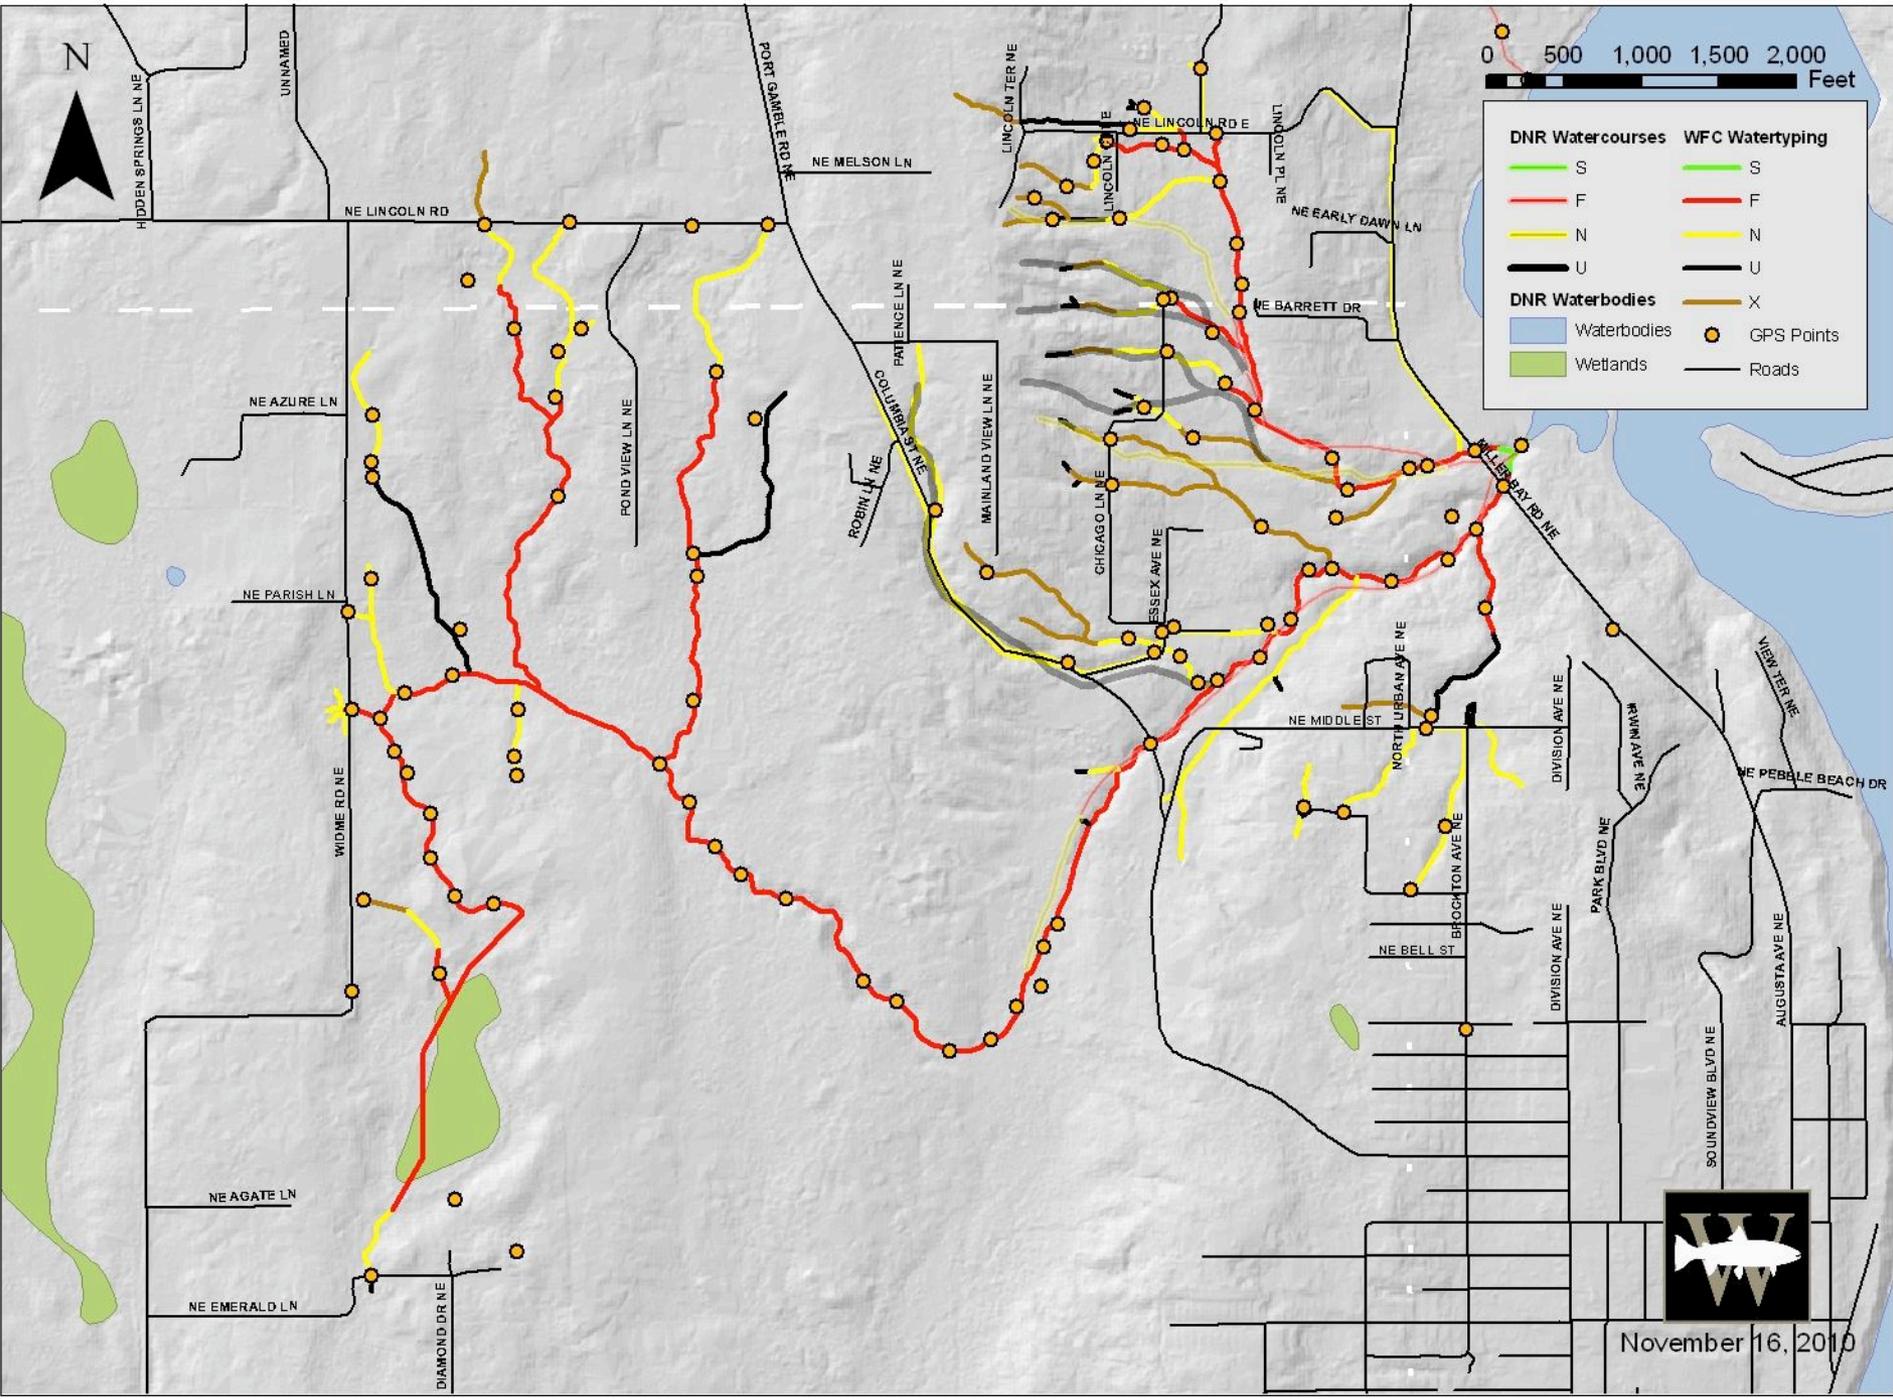
Cowling Creek, Kitsap County

Type	DNR	WFC	
S	0	0.12	
F	1.42	5.46	
N	1.06	5.4	
U	1.84	1.24	Δ
Total	4.32	12.22	7.9

**The regulatory maps missed
66% of this watershed.**

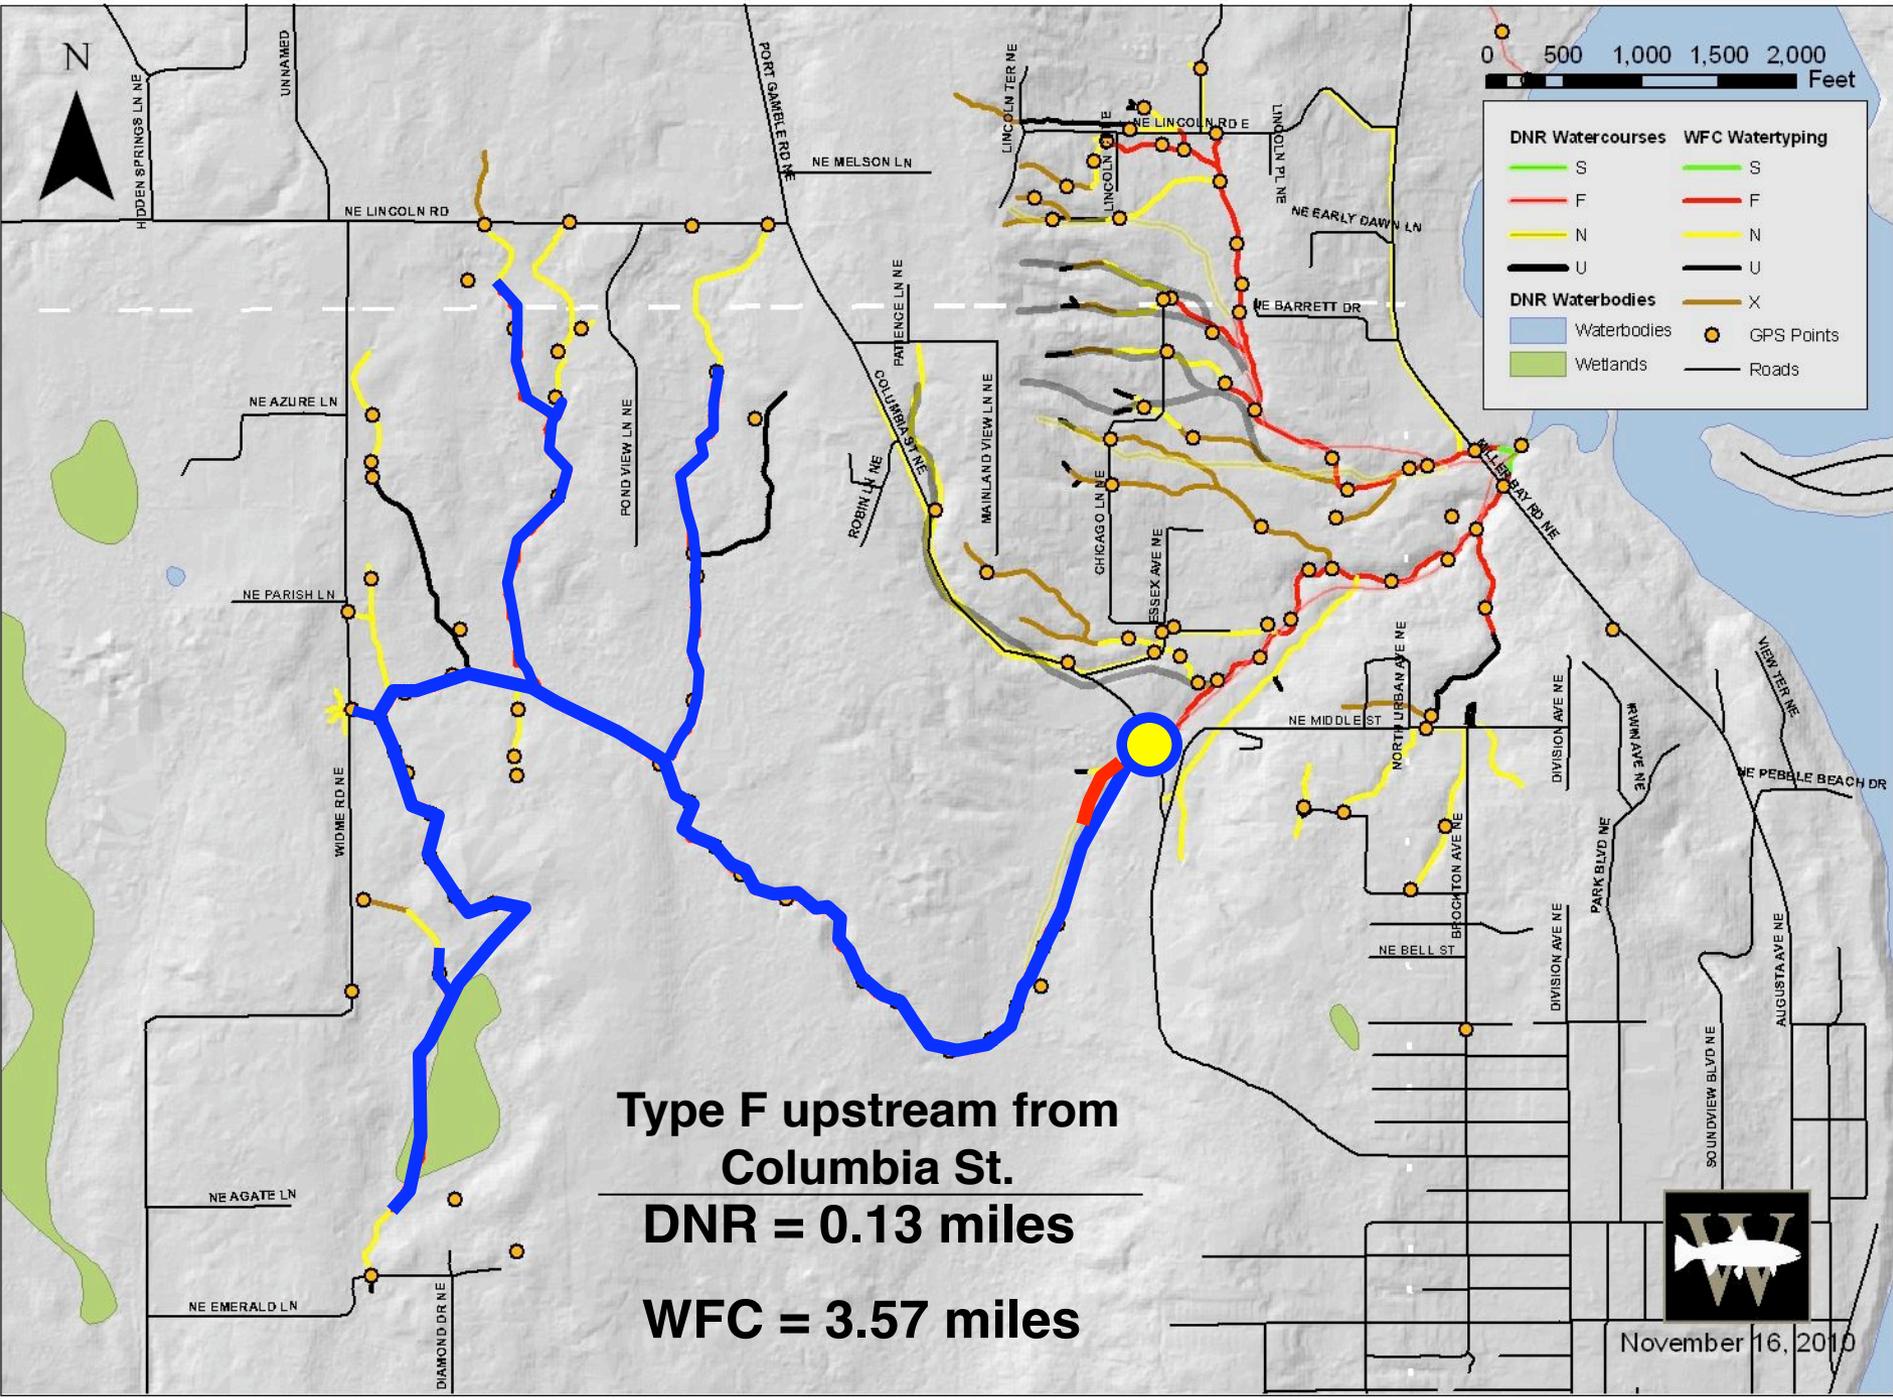
**Type F upstream from
Columbia St.**

DNR = 0.13 miles

WFC = 3.57 miles

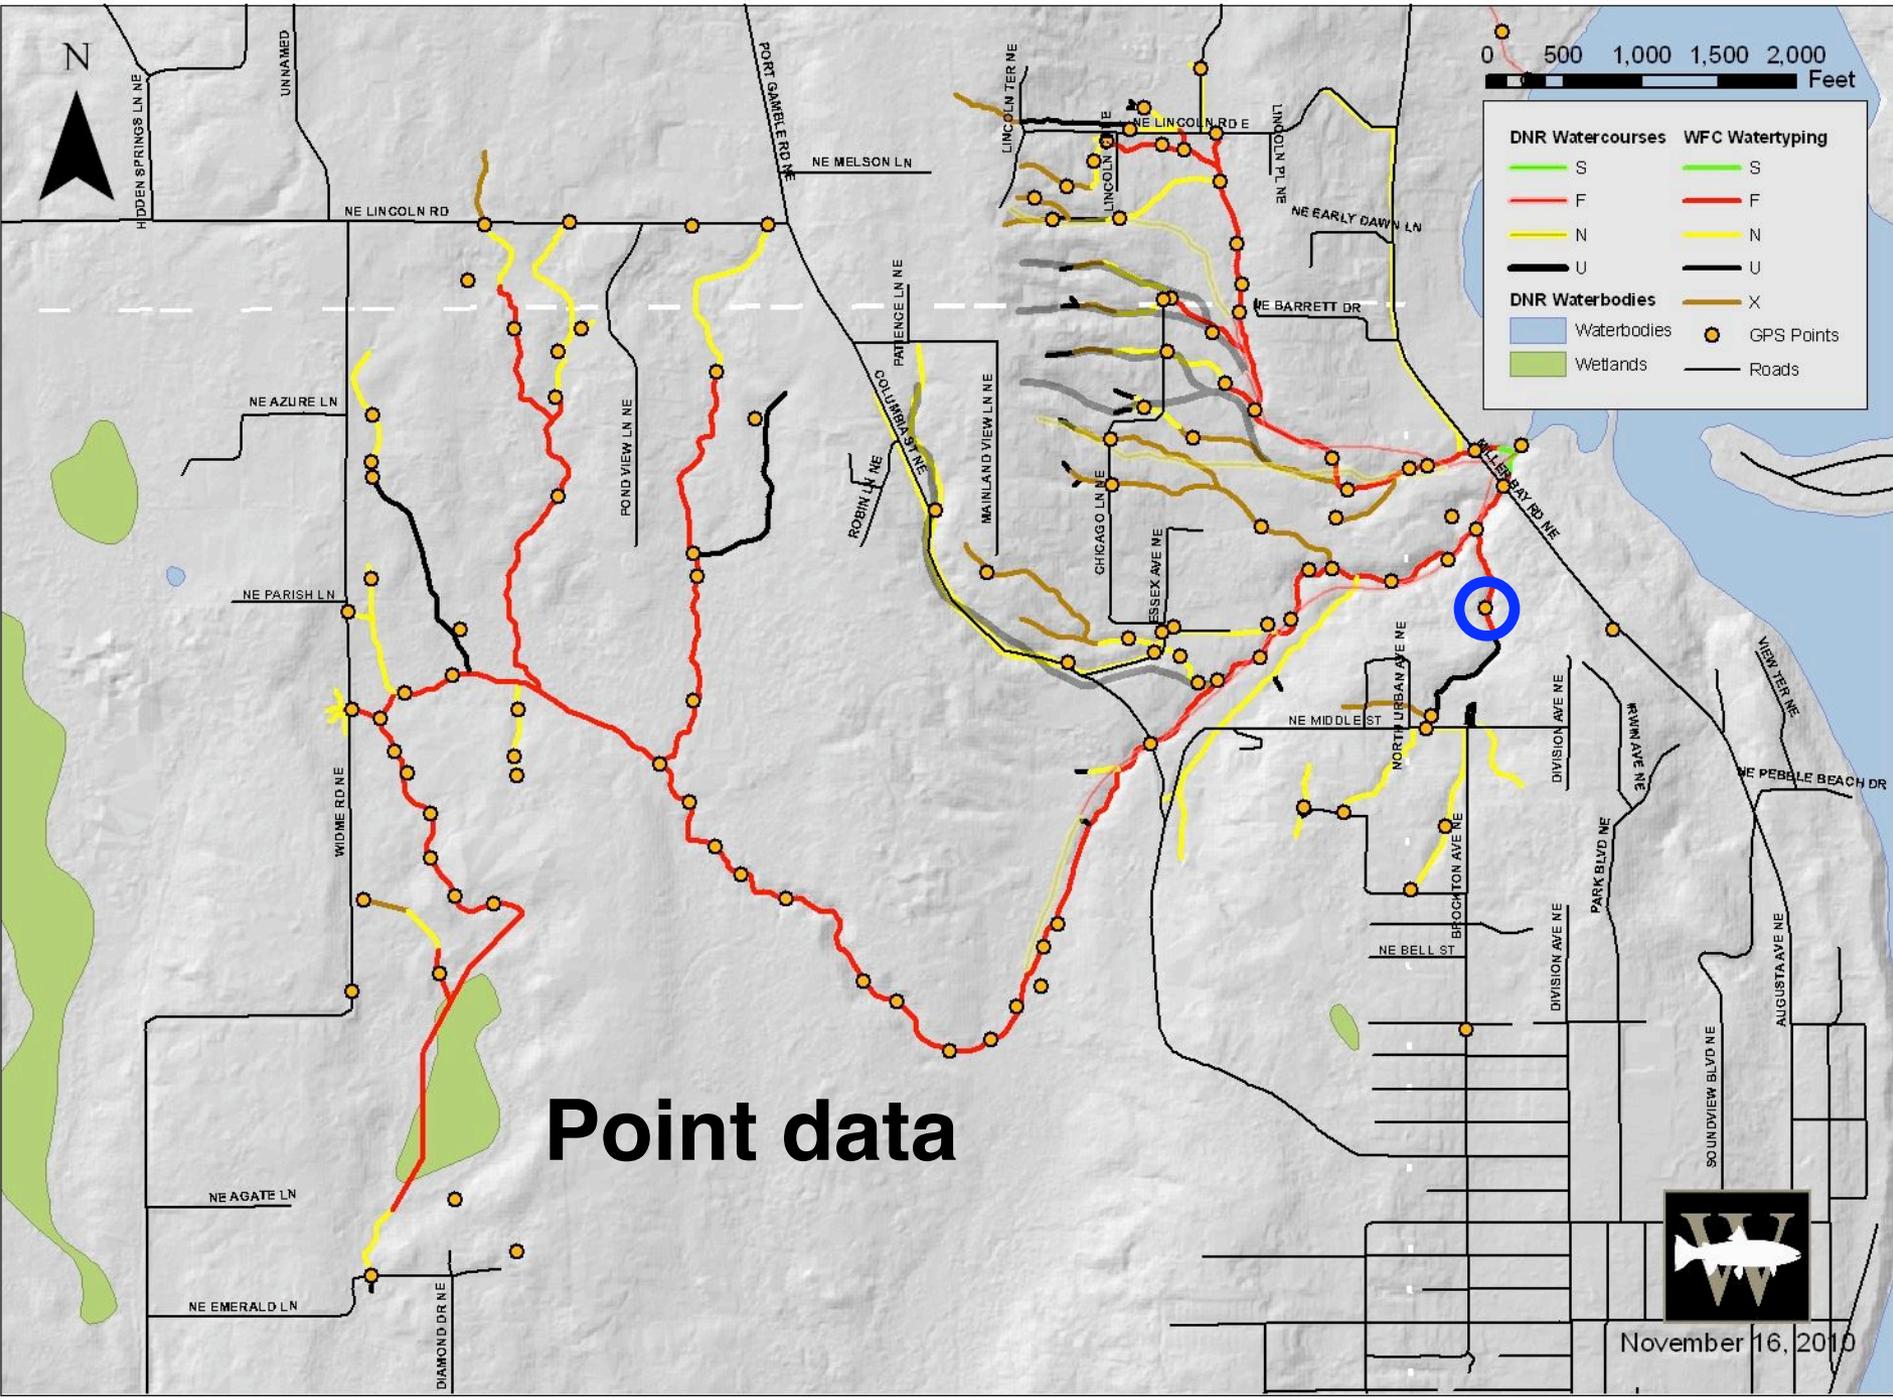
Point data

notes
Culvert: note - this culvert was removed and replaced by a footbridge in 2010. Perched and undersized culvert was previously a total barrier to upstream fish passage, and caused considerable channel scour and incision downstream.

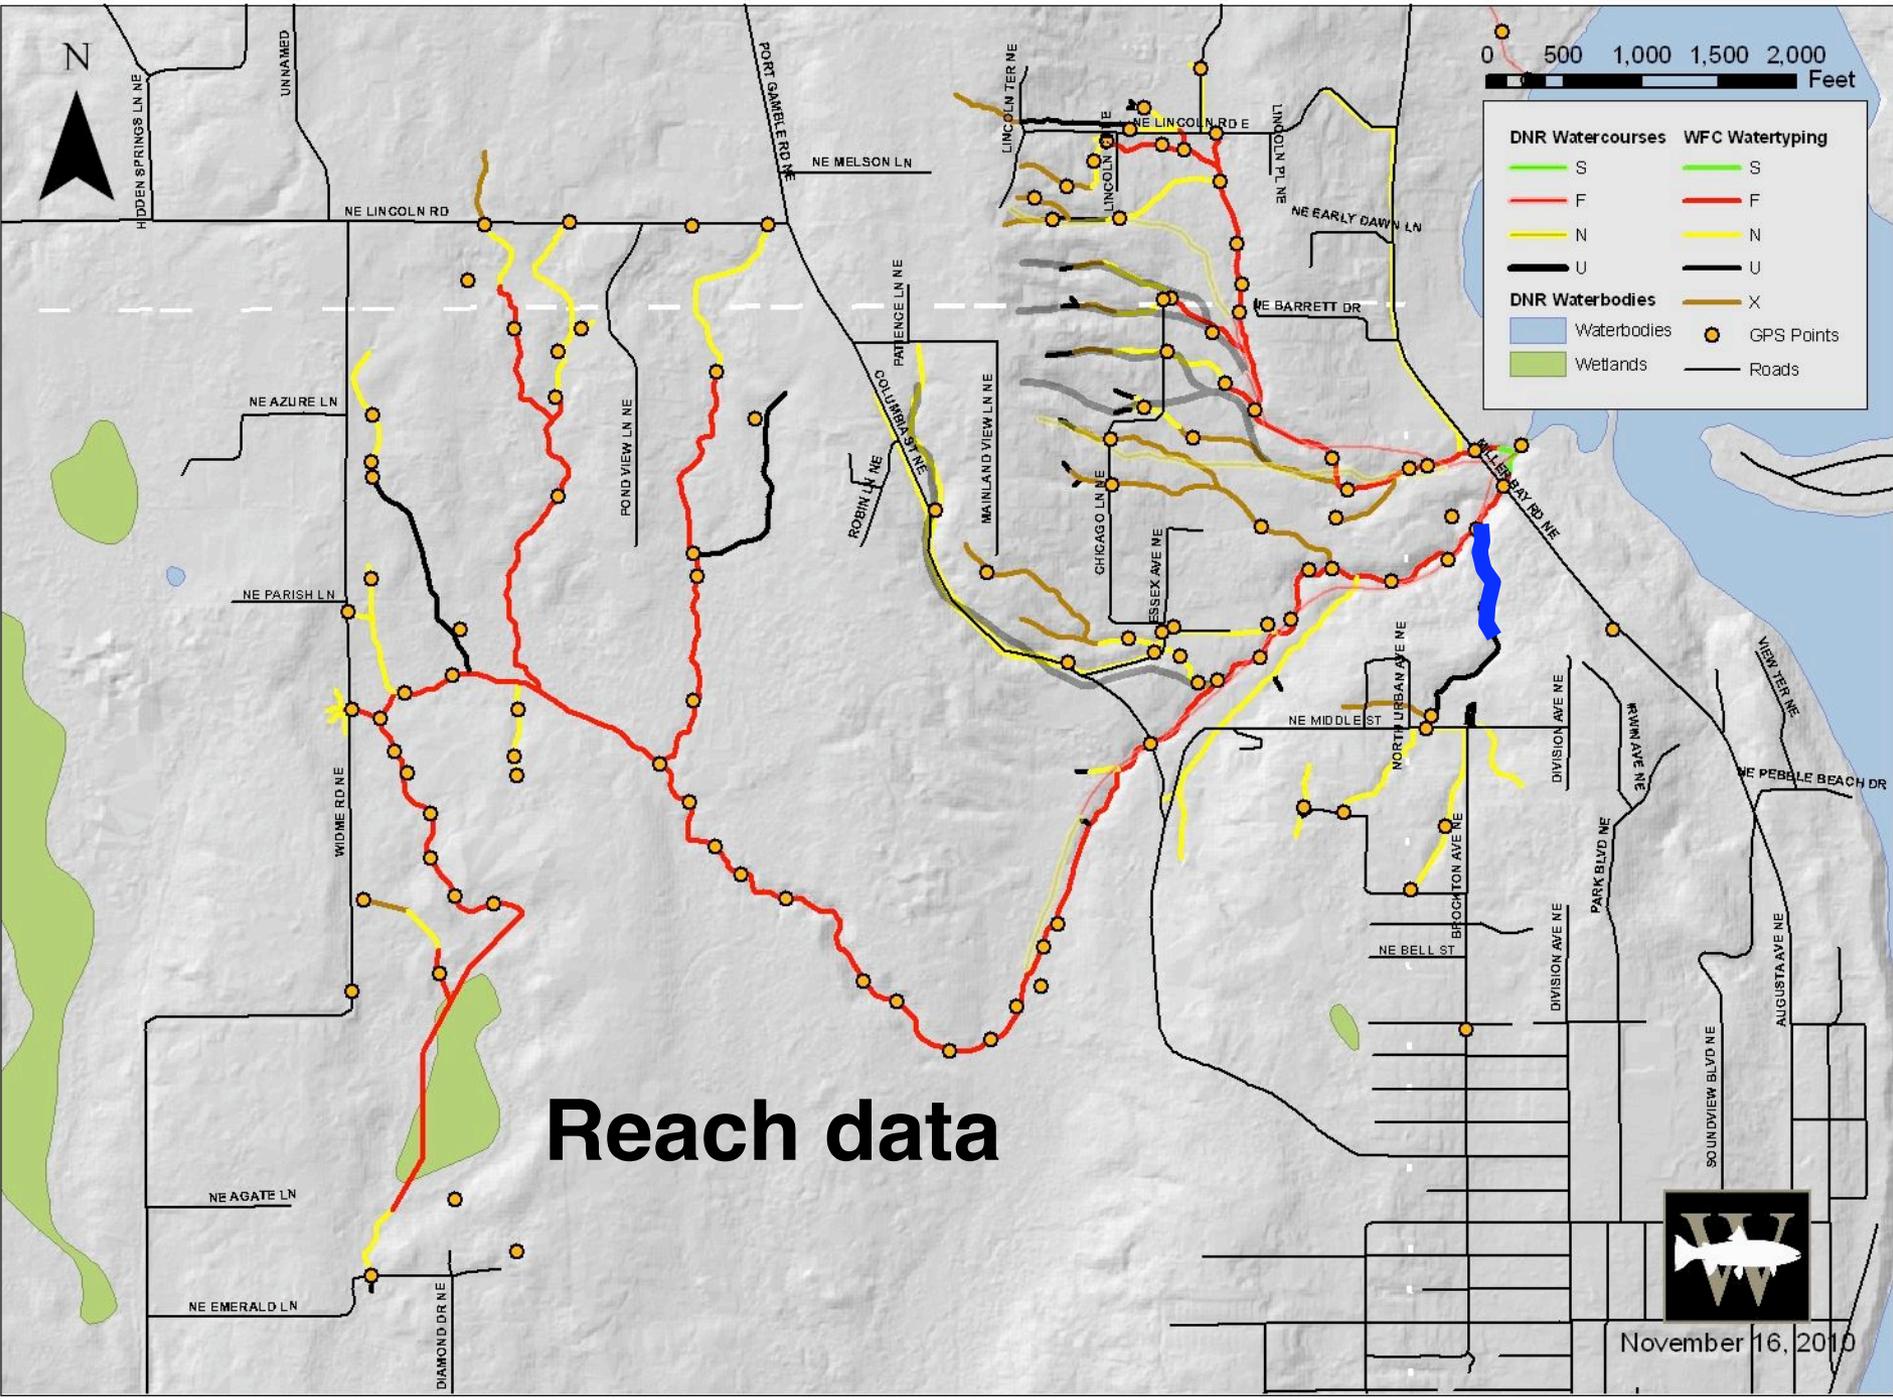
Reach data

ReachID MB01B SubBasinID MB01 Sub Basin Name South Cowling Creek Tributary To Cowling Creek Survey Date 5/25/2010 Crew BT, DD

Avg BFW ft 5 Min BFW ft 3.5 Max BFW ft 6.5 AVGGrad 3-5% MinGrad 1-3% MaxGrad 12-16% Note: Min, max and average from PIDs (use "points" button to the right to see relevant PIDs)

Miller Bay Road culvert(s) on MB01 Cowling Creek is a partial barrier to upstream fish passage into MB01B South Cowling Creek.

MB01B South Cowling is a seasonal stream. Classification was based on physicals because there was no surface flow at the time of the survey.

Notes Stream MB01B "South Cowling Creek" is the second significant upstream tributary of Cowling Creek (MB01), entering from the right bank ~250 ft. above the inlet to the mainstem double culvert crossing of Miller Bay Road, and just below the breached outlet of a concrete impoundment structure associated with former mainstem hatchery operations. The MB01B channel does not currently appear on WDNR water type maps. It is ~8 ft. wide at the confluence, but quickly narrows to an average bankfull width of 5 ft., extending upstream along an incised channel in a brushy ravine, with regenerating (post-harvest) deciduous and conifer forest upslope on valley walls. A former logging road that extends along the left bank of the stream has been converted into a gravel-surfaced footpath as part of the Cowling Creek Center nature trail system, currently managed by the Suquamish Tribe and Great Peninsula Conservancy as a forest preserve. The incised channel has a heavy growth of brush, and small wood debris litters the channel bed throughout, potentially creating temporary blockages until fall freshets can move this material to the channel margins or out of the system. The channel has an average gradient of ~4%, with a short, steeper segment approaching 12% that is located ~350 ft. upstream from the mouth. A former barrier culvert at the crossing of a logging spur/foot trail ~560 ft. above the mouth was removed and replaced with a footbridge in 2010, restoring fish passage into upstream reaches. This perched and undersized culvert was previously a total barrier to upstream fish migration, and likely caused much of the channel erosion and incision noted downstream. Gravel and small cobble predominate along the channel below the old culvert, while the upper channel consists of gravel, silt, and sand in roughly equal proportions. The gradient is reduced again to ~3-5% continuing above the newly-constructed footbridge along a considerable less-incised, more natural-appearing channel for ~180 ft. through denser riparian forest consisting primarily of alders and young conifers to the north boundary of property parcel #G161620715200. We upgraded the previously unclassified MB01B channel to "F" (Type 3) habitat from the Cowling Creek confluence upstream to the property line, but due to lack of access, Wild Fish Conservancy surveyors were unable to determine the upstream extent of fish-bearing habitat which likely extends several hundred feet further to the vicinity of a small (less than 1/2 acre) wetland located adjacent to private driveways near NE Middle Street. Several seasonal non fish-bearing (Ns or Type 5) ditched and diverted channels (MB01B-A, MB01B-B, MB01B-C, and MB01BD) feed this wetland from upslope ravines located to the south of NE Middle Street. These much-altered channels are the headwater tributaries for South Cowling Creek, and contribute considerable surface flow during heavy precipitation events. There was very little surface flow in the MB01B channel downstream from the barrier culvert to the mouth, and the channel above that
